**APPENDIX A: MATERIAL ASSESSMENT SHEETS**

<b>Site ID</b>	21051	<b>Floor</b>	GROUND
<b>Location ID</b>	1051/037	<b>Room / Area</b>	WORKSHOP PARTITION
<b>Building</b>	EAST WORKS	<b>Description</b>	BOARDING ABOVE WINDOWS

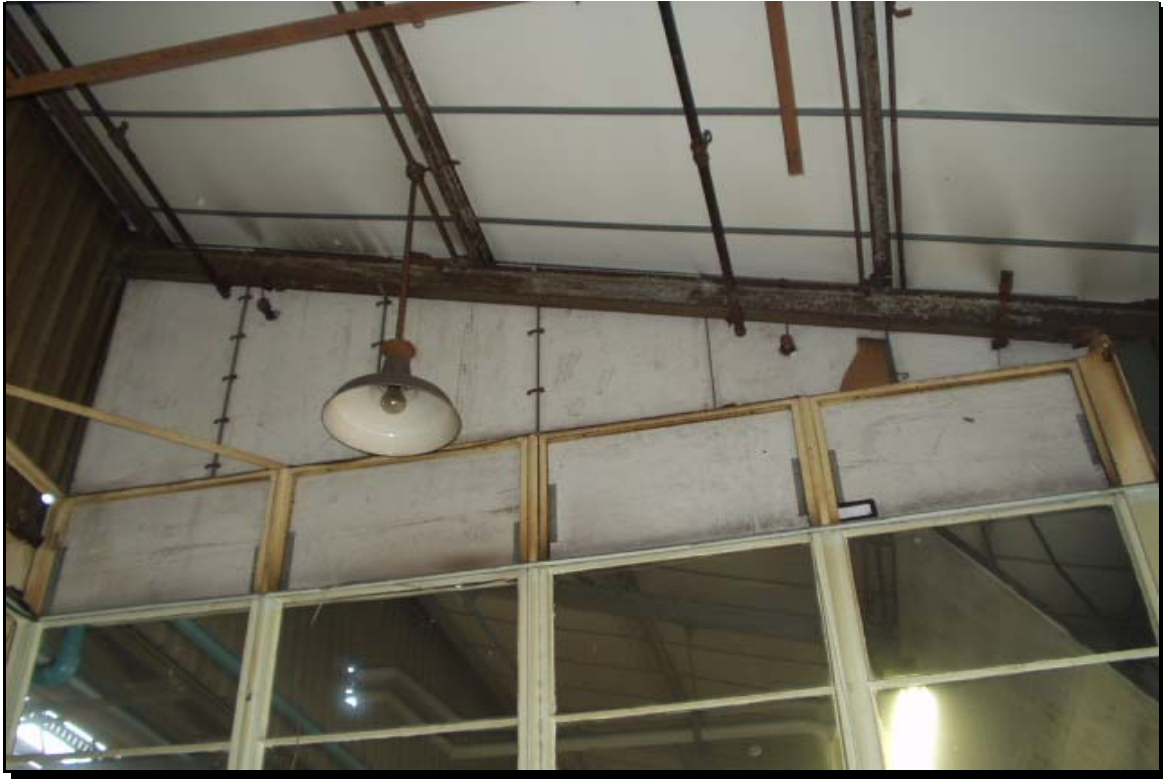
**MATERIAL ASSESSMENT = 7**

<b>Material</b>	INSULATION BOARD	<b>Surface Treatment</b>	UNSEALED AIB
-----------------	------------------	--------------------------	--------------

<b>Condition</b>	LOW DAMAGE	<b>Sample Result</b>	AMOSITE
------------------	------------	----------------------	---------

<b>Action</b>	REPAIR / ENCAPSULATE	<b>Priority</b>	1	<b>Notifiable</b>	YES
<b>Comments:</b>	IN GENERAL GOOD CONDITION BUT WITH SMALL AREAS OF DAMAGE.				
<b>Recommendations:</b>	LICENSED CONTRACTOR TO PAINT WITH SEALANT PRIOR TO LABELLING.
